Case History 169

Iron and Steel Foundry - Machine shop

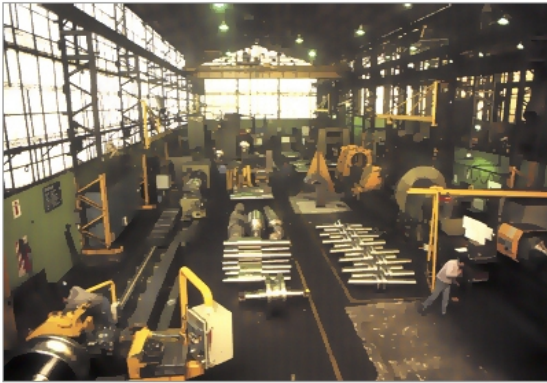
Machine Shop

As an added service, this Buenos Aires Foundry has very large CNC equipment to machine the cast components to meet customer requirements. During the machining process a large quantity of metal chips can be produced.

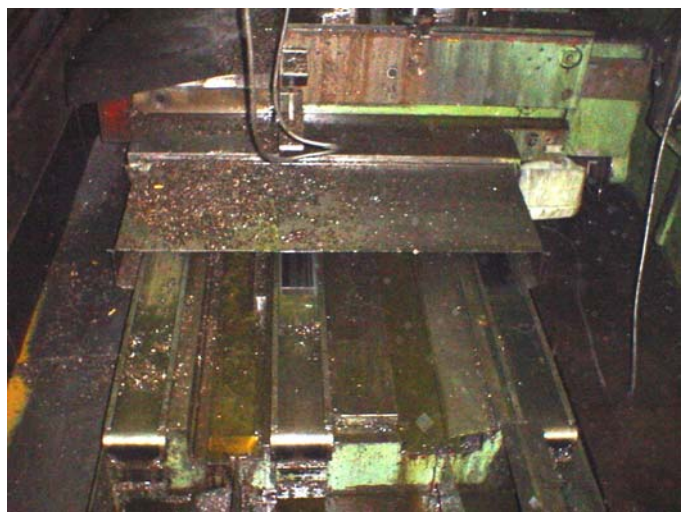
When carrying out the machining operations chips fell on the slide ways and guides. This resulted in costly damage to the machine and production of non-conforming product. Originally a large rubber shield covered the whole area to prevent this problem occurring, but over time cutting fluids and abrasion took their toll and the rubber disintegrated.

Chips seen on slide ways

Six **EXAIR Super Air Knives Model BP110006** were mounted on the carriage (three each side) above the slide and guide ways. The Super Air Knives completely covered the six individual slide ways with a uniform sheet of high velocity air so the chips would be blown off as the carriage of the machine was moved.
